INVESTIGATION OF ACCIDENT TO  
SOUTHERN PACIFIC LOCOMOTIVE NO.  
2833, OPERATED BY SOUTHERN PACIFIC  
COMPANY, WHICH OCCURRED ONE AND  
ONE-HALF MILES WEST OF COSGROVE,  
NEVADA, OCTOBER 3, 1912

REPORT OF CHIEF INSPECTOR OF  
LOCOMOTIVE BOILERS

**REPORT OF THE INVESTIGATION OF ACCIDENT TO SOUTHERN  
PACIFIC LOCOMOTIVE NO. 2833, OPERATED BY THE SOUTHERN  
PACIFIC CO., WHICH OCCURRED 1½ MILES WEST OF COSGROVE,  
NEV., OCTOBER 3, 1912.**

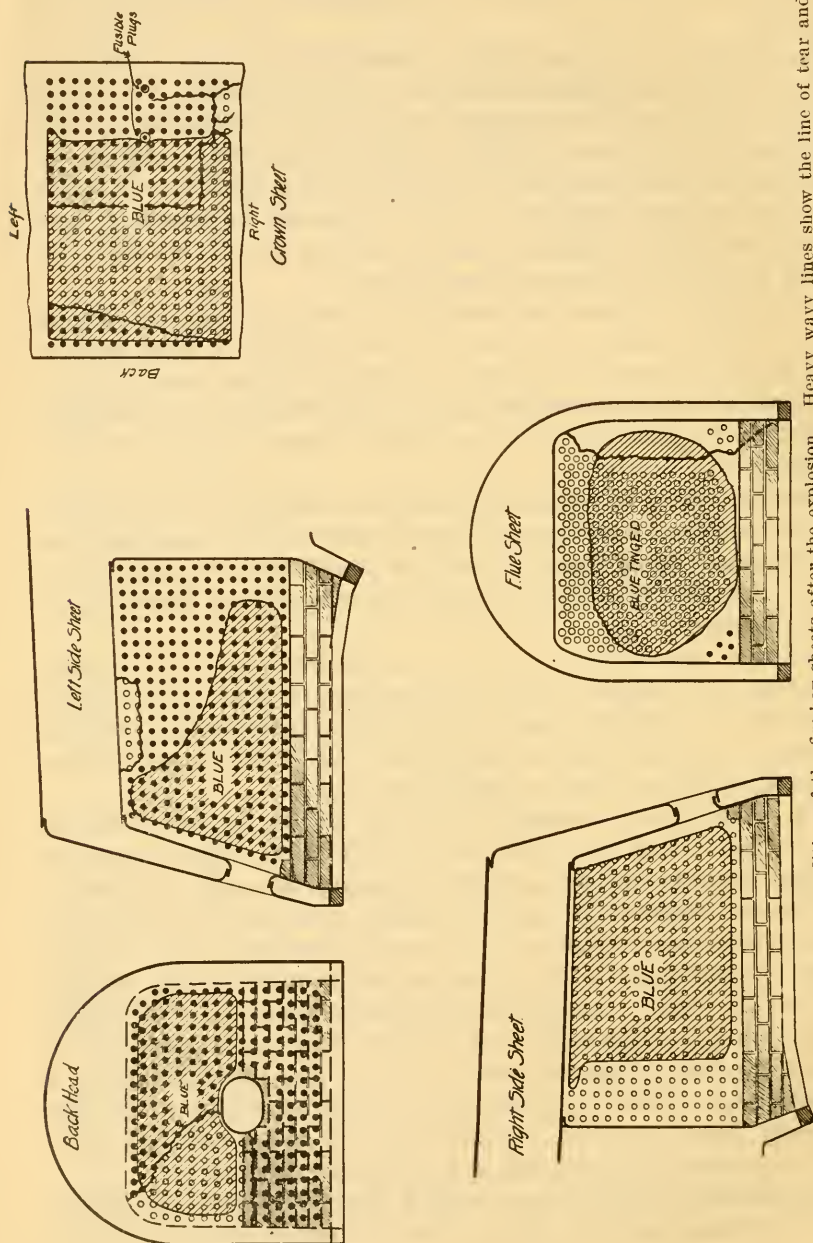
Examination of the boiler showed that the right side sheet, with portions of the right side of flue sheet and door sheet and a portion of the crown sheet, had been blown out. This section of the fire box was blown downward, the sheets having doubled at the top edge of the mud ring and were flattened against the bottom of the mud ring by the boiler rolling to an upright position after landing.

The initial point of failure was in the right side sheet, all of the stay bolts, 382 in number, having pulled out of the sheet. The sheet showed evidence of having been overheated from the third horizontal row of stay bolts above the mud ring, which is the top line of the brickwork, to the top row of stay bolts near the crown sheet, and from the sixth vertical row from flue sheet to the back end of fire box. This sheet, as well as the left side sheet, showed every evidence of having been exceedingly hot. The central part of both side sheets, near the back end of the fire box, had evidently been the

hottest, the temperature having materially decreased near the crown sheet. The flue sheet and flues were tinged with blue from the bottom flues upward, diminishing in hue toward the upper flues. The crown sheet had been overheated from the back end to a point between the fifth and sixth lateral rows of crown bolts from flue sheet, at which point the line of overheating was clearly defined, crossing from side to side, and the sheet in front of this, which was the highest part of the crown sheet, did not show any evidence of overheating. The crown flange seam of the flue sheet did not show the slightest sign of having been overheated. The rivets were intact, and the calking edge not sprung. Neither did the longitudinal corners or bends of fire box between the top rows of stay bolts in side sheets and outside rows of crown bolts show any indications of having been overheated.

The manner in which the sheets were overheated shows conclusively that this accident was due to the character of the water used on this division, as the hottest portion of the sheets was just above the line of brickwork, about 12 inches from the mud ring, while the fusible plugs in the crown sheet remained intact, and the front end of the crown sheet, which is the highest portion, shows no indication of having been overheated, which is evidence that the water covered this area until the last moment prior to the explosion.

The overheated areas in the fire box are shown in the diagrams contained in this report.

Until such time as better water can be obtained, it would increase the safety of operation of these locomotives to reduce the tonnage or the speed of trains so that it would not be necessary to force the boilers to an extent which endangers the lives of employees in order to generate sufficient steam to operate the trains.

If it is absolutely necessary that these boilers be forced to use every heat unit that the burners can give forth in order to generate sufficient steam to handle the desired tonnage, or make the time, it would be a safeguard to apply a fusible plug near the back end of the crown sheet at the point where the greatest heat from the burner is concentrated. Applying a fusible plug in this manner may possibly result in increased engine failures, as it is a well-known fact that under certain conditions sufficient heat can be generated by a forced oil fire to fuse the metal in such a plug, even though it is covered by water, but it would serve to give warning that the fire was being forced beyond the point of safety, and would materially add to the safety of operating locomotives in this district.

The condition of the fire-box sheets in locomotive 2833 also demonstrates the fact that the heat from the oil burner is not uniformly diffused throughout the fire box. Correcting this defect will, in a measure, reduce the liability of overheating fire-box sheets which are covered with water.
